NATIONAL HISTORIC LANDMARK NOMINATION

BATTLE MOUNTAIN SANITARIUM, NATIONAL HOME FOR DISABLED VOLUNTEER SOLDIERS Page 1

Historic Name: Battle Mountain Sanitarium, National Home for Disabled Volunteer Soldiers

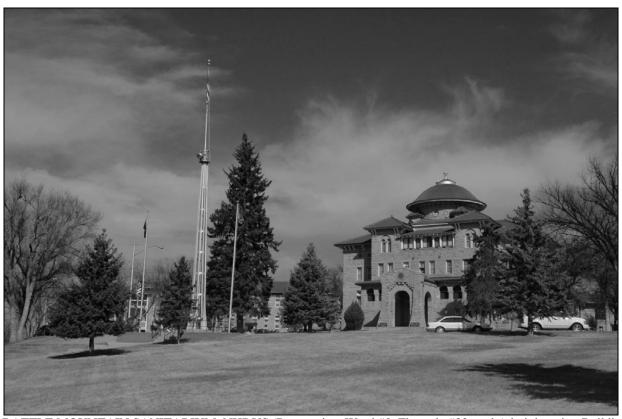
BATTLE MOUNTAIN SANITARIUM, NHDVS (Perspective: Ward #8, Flagpole #33, and Administration Building #1), 500 North 5th Street, Town of Hot Springs, Fall River County, SD, view to north. Photograph by Brian McCutchen, 2005.

This building is the focal point of Kimball's hospital design. The complex features a symmetrical pavilion plan designed around a 160' diameter inner courtyard. About the circular design are a central administrative section and six radiating wards all accessed by a circular arcade. The administration/hospital building faces southwest towards the Hot Springs commercial district. It is built of pitch-faced sandstone laid in a rough cut random pattern, and is three and one-half stories tall with a full daylight basement. Roof material is tile with decorative brackets. Rafter tails are at the eaves. Windows are generally six-over-six, set within openings trimmed with ashlar quoins. An ashlar string course above the windows creates a continuous window lintel for the first- and second-floor windows. The upper story windows have semicircular arches.

Building 8 follows the design of the other ward wings. The long porch is on the north side of the building. Areas between the piers are not filled in. Building 8 is used as a domiciliary and recreation building.

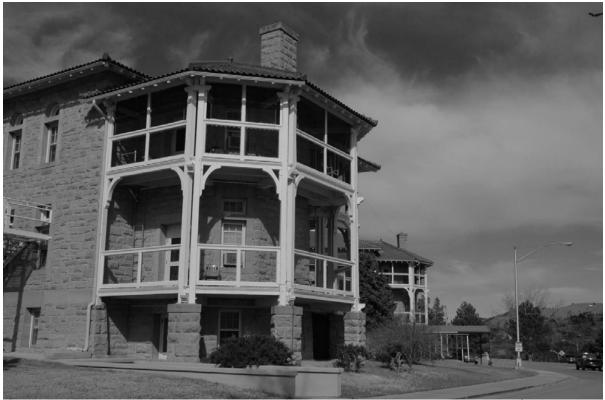
BATTLE MOUNTAIN SANITARIUM, NHDVS (Perspective: Wards # 4 and #5), 500 North 5th Street, Town of Hot Springs, Fall River County, SD, view to northeast. Photography by Brian McCutchen, 2005.

Building 4 is the same general design as Building 3, but has no entrance bay. The porch is on the northeast side. Building 4 is presently used as a domiciliary for female patients and will be converted for use by Gulf War veterans by 2011. Work will include installing an elevator and remodeling three floors, including partitioning the ward area for office space and patient space.

Building 5 is the same general design as Buildings 3 and 4. The porch is on the north-facing side. A roof covered in red tile and supported by metal poles extends over the entrance to the street. Portions of the piers have been infilled. A two-story addition on the south-facing side is built of pitch-faced stones set in a rough cut random rubble pattern. The stones are similar in color to those used in the original building. The addition carries a pent roof. Windows on each floor of the addition are six-over-six, with ashlar quoins and a semicircular arch. To the southwest is a covered walkway consisting of a gabled roof on pole supports. This was installed in 1988, when smoking was banned inside the building. Building 5 is used as a domiciliary and canteen.

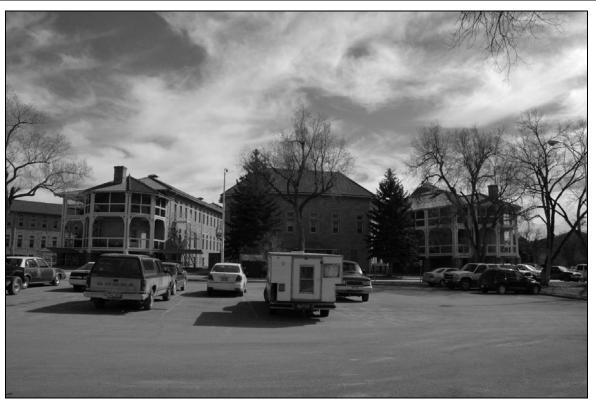
BATTLE MOUNTAIN SANITARIUM, NHDVS (Perspective: Wards #6, #7, Auditorium/Library #11, and Ward #8), 500 North 5th Street, Town of Hot Springs, Fall River County, SD, view to southeast. Photo by Brian McCutchen, 2005.

Building 6 follows the general design of the other wards. Its porch is located on the northeast side, and portions between the piers are infilled. A small one-story stucco addition on the northeast corner, constructed about 1978, has a door opening to a loading dock area but no windows. The addition is sympathetic to the original design, carrying sandstone decorative elements at the corners and a hipped roof covered in tiles. Building 6 is used as a domiciliary and warehouse.

Building 7 also follows the design of the other ward buildings. Its porch is located on the northeast side. Portions between the piers have been infilled. A covered walkway similar to that on Building 5 leads to a north-facing door and to a west-facing door. Building 7 is used as a domiciliary and recreation building.

This building was constructed as an addition to the original complex to provide a multi-use space for a chapel, assembly hall, a billiard and card room, barber shop, library, and post store. The first floor was completed in 1914 and the auditorium space above finished in 1915. The two-story building is an elongated octagonal located between Building 7 and Building 8. Like the administration and hospital wards, the library is built of pitch-faced sandstone laid in a rough cut random pattern. The entry door faces northwest and is sheltered by a pent roof canopy. Windows are six-over-six, with second floor windows matching those on the first floor of the wards. Building 11 has two entry doors, rectangular windows with transoms, and a fire escape on the northwest. The building is connected to the central arcade by a two-story gabled frame section with six-over-six windows. An elevator has been installed. The interior retains the original small stage with its lighting system and orchestra pit. Building 11 is used as a library and museum. The library was converted into a VISN call center in spring 2010. The walls remain intact but all shelving has been removed on the first floor. Part of the shelving and books are now in the upper arcade. Since 1996 the VA museum has occupied the north half of the building.

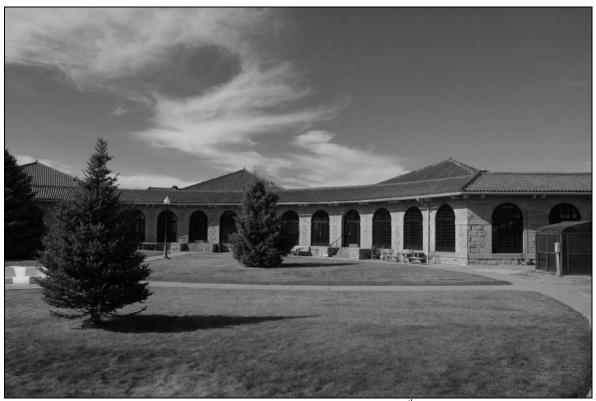
BATTLE MOUNTAIN SANITARIUM, NHDVS (Courtyard), 500 North 5th Street, Town of Hot Springs, Fall River County, SD, view to north. Photo by Brian McCutchen, 2005.

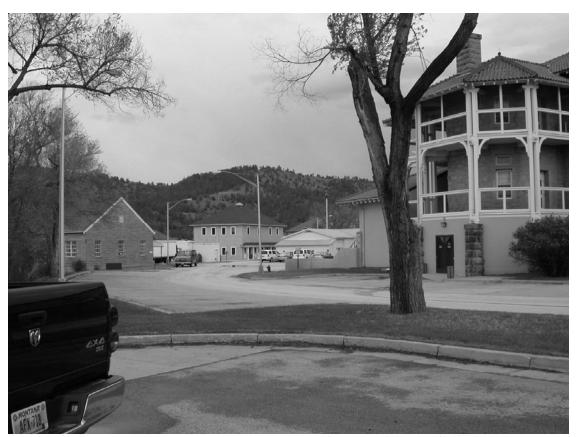
BATTLE MOUNTAIN SANITARIUM, NHDVS (Perspective: Laundry #43, Oil Shed #57, Engineering #14, Fire Station #30, Ward #6), 500 North 5th Street, Town of Hot Springs, Fall River County, SD, view to east. Photo by Dena Sanford, 2007.

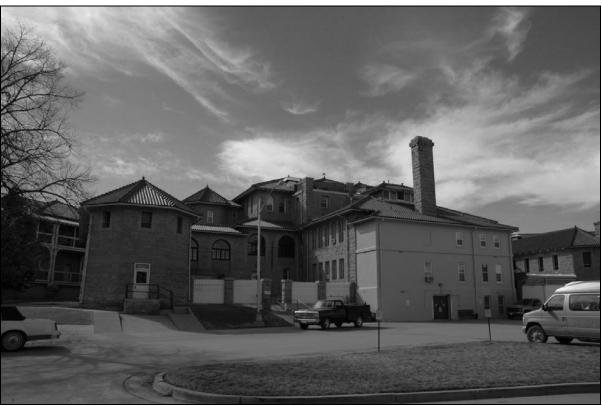
BATTLE MOUNTAIN SANITARIUM, NHDVS (Plunge/Protestant Chapel #9, Mess Hall #2, and Maintenance/ Catholic Chapel #10), 500 North 5th Street, Town of Hot Springs, Fall River County, SD, view to southwest. Photo by Brian McCutchen, 2005.

Building 2, which holds the original kitchen, mess hall, and food storage area, is centered between Buildings 9 and 10. Like the administration building, Building 2 is constructed of pitch-faced sandstone laid in a rough cut random pattern. It has a hipped roof covered in clay tiles, and six-over-six windows similar to those on Building 1. Building 2 is designed in two sections: a three-story section with an open porch on the northeast side and a two-story section immediately to the northeast that also has a hipped roof, but is pierced by a central hipped dormer. This second, lower section has the typical windows on the northwest and southwest sides, sharing continuous lintels and sills. Three-story hexagonal towers on the southeast and northwest ends of Building 2 hold spiral staircases. There is a large stone interior chimney that was probably originally located on an exterior wall on an open porch. The porch has been infilled. A picket fence with stone columns extends northwest and southeast, enclosing spaces between Building 2 and Buildings 9 and 10. The mess hall ceiling has been lowered, but the space contains original woodwork and windows. The kitchen's original ceiling is still in place, and the early exhaust fan is still present. A dividing wall has been erected to create a cooking classroom. Building 2 also originally served as quartermaster and commissary rooms. Both the kitchen and dining room are still used for their original purposes. The top floor of Building 2, originally used to house servants, has been renovated for classrooms and offices and an elevator has been added.

Two two-story buildings –Buildings 9 and 10— are located on the northeast side of the complex on each side of Building 2. They are constructed of the same pitch-faced stone as the administration building and wards. They feature polygonal end walls and hipped roofs with windows located near the eaves. Narrow rectangular windows are on the sides. An ashlar stone belt course is located at the first floor window level. Both buildings were converted to chapels in the late 1940s or early 1950s. Building 9 held two plunge baths for therapeutic bathing in the mineral waters. The plunges were separated by dressing rooms. Building 9 is now the Protestant chapel, but original plunge bath steps and tile work remain in the basement. The original wood frame, double-hung windows were replaced with leaded stain glass windows in 1957. The walls remain intact on both levels.

Building 10 is nearly identical to Building 9. Kimball's plan for the building identified the building's primary use as a billiard hall, although the basement uses noted in pencil on the drawing were for laundry and amusement. By 1919 it held a chapel as well.⁴ A small brick one-story, flat-roofed extension on the southeast side of Building 10 holds an emergency generator. The extension, built in the late 1950s or early 1960s, covers the rectangular windows on the first floor of that side. Building 10 is now the Catholic chapel. The original wood frame, double-hung windows were replaced with leaded stain glass windows in 1957. The walls remain intact on both levels.

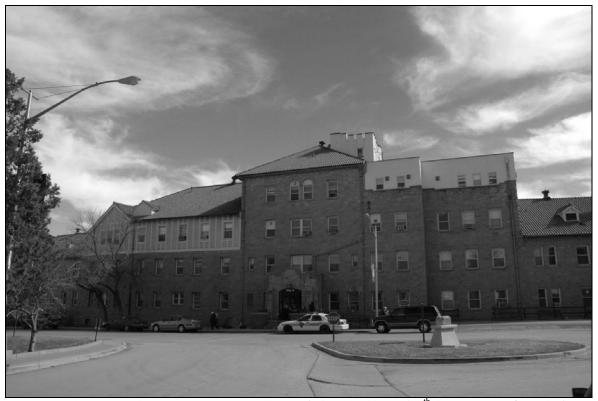
BATTLE MOUNTAIN SANITARIUM, NHDVS (Hospital #12), 500 North 5th Street, Town of Hot Springs, Fall River County, SD, view to southeast. Photo by Brian McCutchen, 2005.

This large hospital complex consists of the original structure built by the Veterans Bureau in 1926, a major addition built in 1937, and smaller additions built in the 1950s, 1980s, and 1990s. The original sandstone building replaced a barracks for tubercular patients on this location. The main facade faces northwest and presents eight bays that vary in height and roof form, combining elements of Mission, Tudor Revival, and Romanesque Revival design. Arched and rectangular windows, generally six-over-six, are accentuated with voussoirs appear in each bay. The majority of roofing is red tile. From east to west on the south side, the bay heights and roof forms as follows: First is a two-story hipped roof bay with hipped roof dormers and a Tudor style wall dormer with "half timbering." Adjacent is a three-story hipped roof bay with Tudor "half timbering" in the upper story and large wall dormer. Centrally placed is a four-story Mission Style bay oriented on a northwest/southeast axis. It has a pyramidal hipped roof. West of this is a three-story bay with shallow parapets; then a two-story, gabled bay with gabled dormers and finally a two-story gable end bay with a gablecovered entrance. Above the two three-story bays are additions dating to 1937 that consist of stucco over concrete. There is a small battlemented tower that rises behind (southeast) of the four-story pyramidal roof bay. A modern metal and glass door is inset in the original entry under the inscription "Veterans Bureau 1926." The central bay of its southwest facing façade holds an elevator tower with sandstone and half-timbering accents, stylistic elements that tie the addition to the original building. On the north side, the grade drops away,

allowing for a full-daylight basement. Later additions to the Hospital (see Building 65; Building 62, under Structures) are nearly invisible from the campus core. The interior of the original hospital building has been completely renovated to provide modern patient care.

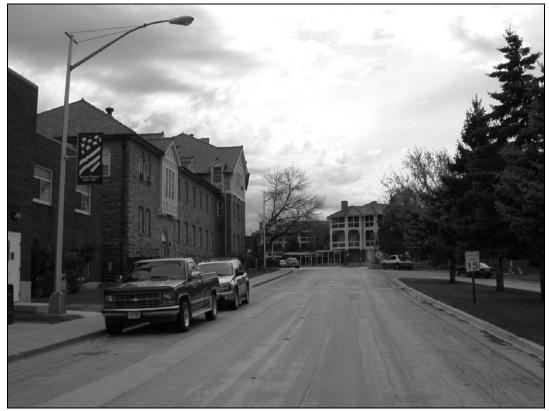
BATTLE MOUNTAIN SANITARIUM, NHDVS (Perspective: Hospital #12, Wards #4 and #5), 500 North 5th Street, Town of Hot Springs, Fall River County, SD, view to west. Photograph by Dena Sanford, 2007.

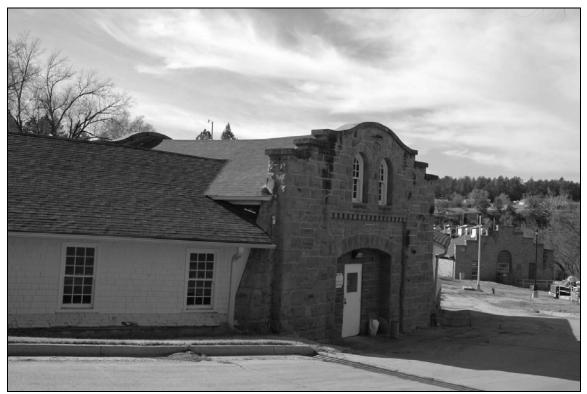
BATTLE MOUNTAIN SANITARIUM, NHDVS (Perspective: Stable/Equipment Repair #17, and Power Plant #18), 500 North 5th Street, Town of Hot Springs Fall River County, SD, view to northwest. Photograph by Brian McCutchen, 2005.

One of the original group of Thomas Rogers Kimball buildings, the stable and carriage house was designed in a V-plan and features a north-facing entrance bay of pitch-faced sandstone laid in the typical rough-cut random pattern. The wide, recessed entry, created within a segmental arched opening, is under a shaped and stepped parapet. The original entry has been partially bricked in and holds a new door. Two arched windows with sandstone voussoirs are centered above the entry. Wood frame wings on each side of the entry bay rest on sandstone foundations and angle to the southeast and northwest. They have hipped roofs covered in asphalt shingles. The wood walls, sided in yellow painted wood shingles, are flared at the base to meet the sandstone foundation. The easternmost wing holds five nine-over-nine rectangular windows; its end has two large vinyl garage doors and its west side features three rectangular windows. The westernmost wing has nine small six-light windows on its north-facing side. Its end is sandstone on the first level with centered double wooden entry doors. A window on the second level holds a vent. The west side of this wing carries a row of twelve-over-twelve double hung windows and an entry door. The rear of the entry bay has a centered garage door under one
